# Flood Risk Readiness and Architectural Mitigation Strategies for Religious Premises: A Case Study of Luhanga Catholic Church, Dar es Salaam, Tanzania

Henry M. Rimisho

Ardhi University (ARU), P.O. Box 35176, Dar es Salaam, United Republic of Tanzania

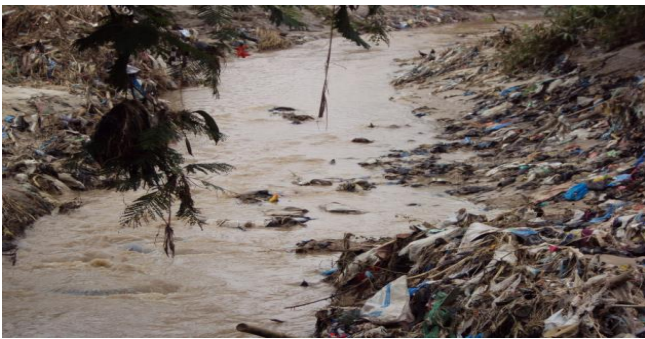
The church compound is situated between two stormwater drainage channels. The principal channel conveys runoff from upstream catchments, including Mbezi, Kimara, and Kigogo, before discharging into the Indian Ocean through the Jangwani floodplain. During periods of intense rainfall, the existing channel capacity becomes insufficient, resulting in overtopping of the riverbanks and inundation of the church premises.

The secondary drainage channel located east of the site further contributes to flooding by conveying runoff from surrounding neighbourhoods into the main drainage system.

**Image 3.2.** Major and minor stormwater channels surrounding Luhanga Catholic Church. Source: Figures adapted from Google Maps (2025) and field survey (2025)

First, the church is located between two interconnected stormwater channels whose hydraulic capacities have become inadequate for present runoff conditions. During heavy rainfall, the channels overflow and inundate adjacent land uses, including the church compound.

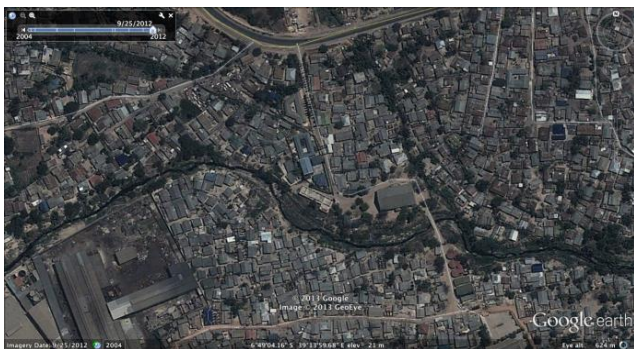
Rapid urbanisation surrounding the church has substantially increased impervious surfaces, including buildings, roads, parking areas, and industrial compounds. Consequently, rainfall infiltration has declined while surface runoff has increased considerably.

Because the church premises occupy one of the lowest elevations within the neighbourhood, stormwater generated from surrounding residential and industrial developments naturally converges toward the site, thereby increasing flood frequency and intensity.

**Image 3.3.** Uncontrolled surface runoff from unplanned neighborhood flows toward the site. Source: Adapted from (Google Map, 2025)

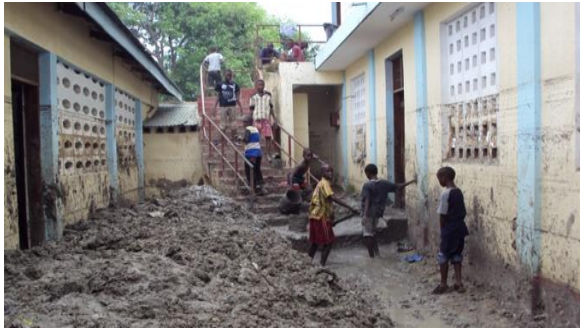
Floodwaters have repeatedly affected the church buildings, parish offices, Sisters' residences, and hostel facilities. Damage includes water intrusion into buildings, deterioration of construction materials, restricted access, and disruption of religious and community activities.

**Image 3.5.** Flood damage observed within Luhanga Catholic Church premises. Source: Field survey (2025)

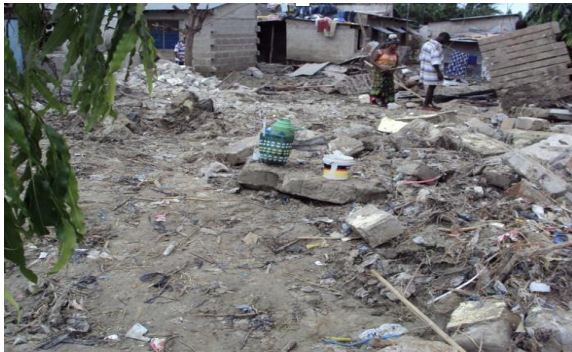
**Image 3.6.** Flood damage observed beside Luhanga Catholic Church quaters. Source: Field survey (2025)

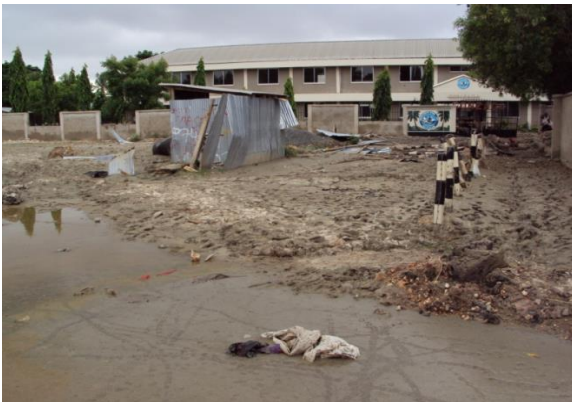
**Image 3.7.** Flood impacts on MEMKWA premises. Source: Field survey (2025)

Flooding also affected nearby MEMKWA educational facilities through inundation of classrooms, open spaces, and pedestrian circulation areas.

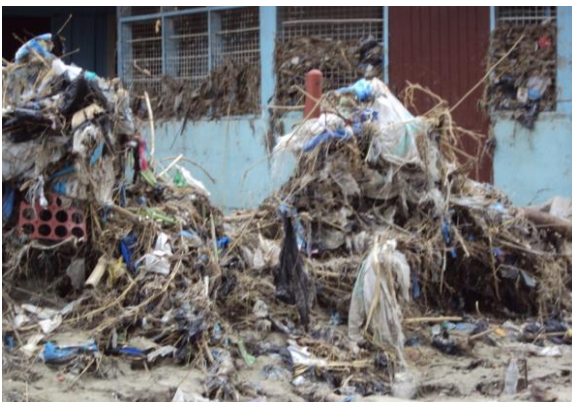
**Image 3.8.** Damage at Memkwa premises. Source: Field Survey, (2025)

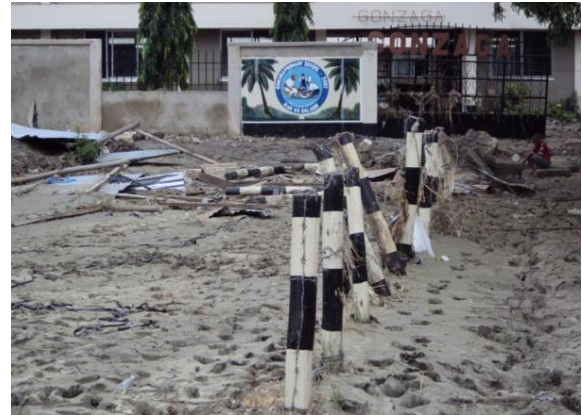
Floodwaters disrupted educational activities at Gonzaga Primary School through damage to access routes, drainage infrastructure, and surrounding open spaces.

**Image 3.9.** Flood impacts on Gonzaga Primary School. Source: Field survey (2025)

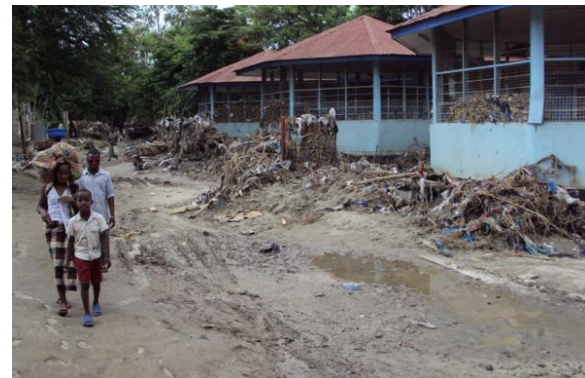
**Image 3.10.** Flood impacts on Gonzaga Primary walkways. Source: Field survey (2025)

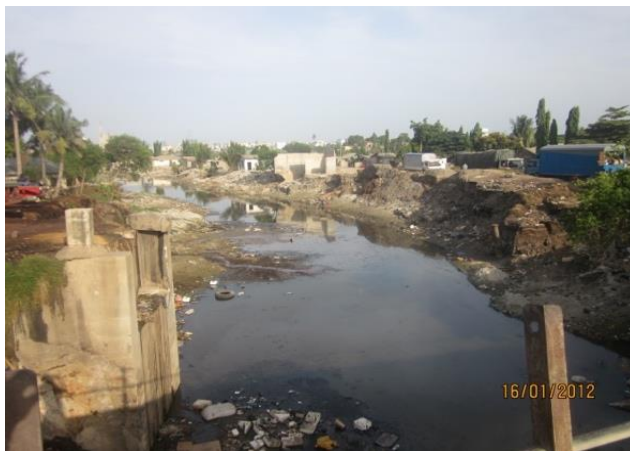
- construction of reinforced riverbank protection structures (dikes) along vulnerable stormwater channels;
- expansion and rehabilitation of existing drainage channels;
- installation of additional stormwater conveyance systems;
- localized flood retention and detention facilities; and
- hydraulic improvements that increase channel carrying capacity.

**Image 6.1.** Comparative flood impact showing protected and unprotected riverbank sections. Source: Field survey. (2025)

The proposed structural interventions are illustrated in Image 6.1 and 6.2:

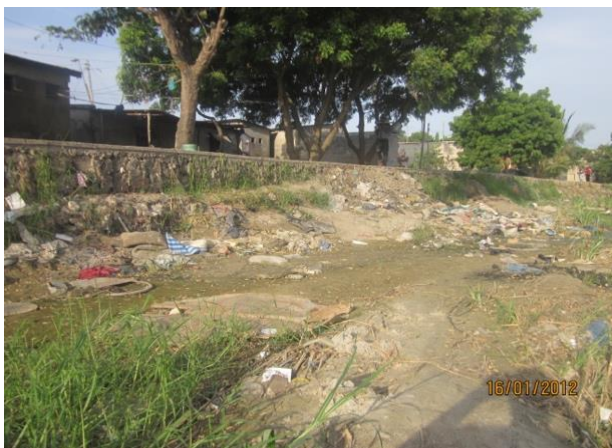
**Image 6.2.** Differential flood exposure along Kigogo Mbuyuni river valley (Field Survey). Source: Field survey. (2025)

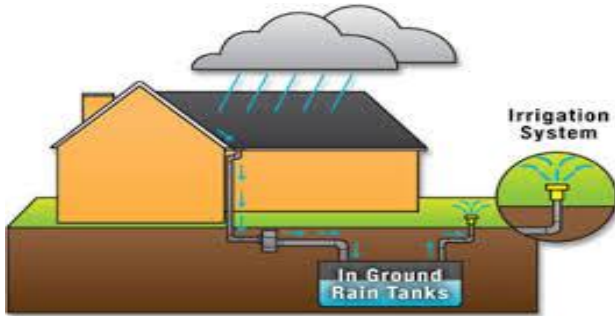
**Rainwater Harvesting:** Implementation of **15,000-liter ground storage tanks** for rainwater collection can significantly reduce surface runoff and flood risk.

**Image 6.14.** Shows harvesting rain water to reduce surface runoff. Source: Field survey, (2025)

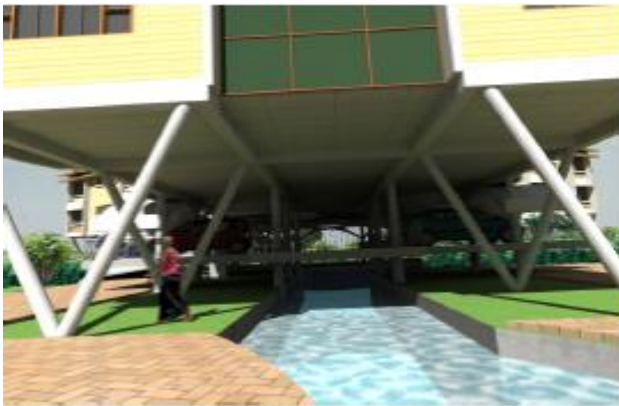
**Safe Building Construction:** Flood-resistant, suspended, or mixed-use buildings can safeguard lives and property. Design should include flood precautions such as elevated floors and protected basements.

**Image 6.15.** Shows the mixed use suspended building with flood precautions. Source: Field survey, (2025)

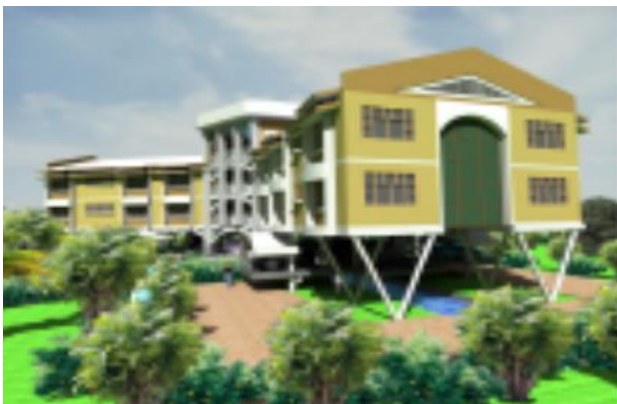
**Image 6.16.** Shows the safe zones/building with suspended piles for flood precautions. Source: Field survey, (2025)

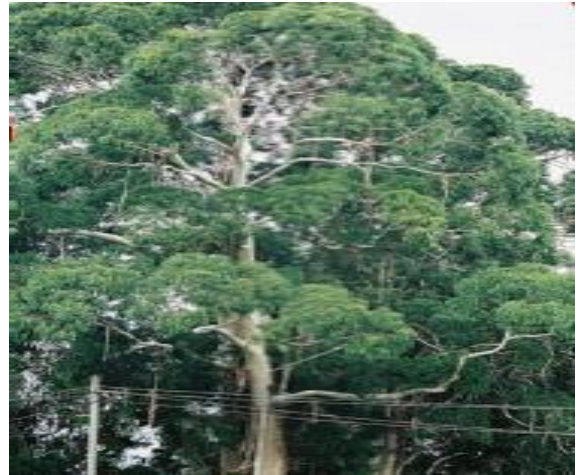
**Landscape Management:** Reducing impervious surfaces and planting water-absorbing vegetation, such as eucalyptus and elephant grass, enhances percolation and reduces runoff.

**Image 6.17.** Shows the landscape flood control by planting trees. Source: Field survey, (2025)

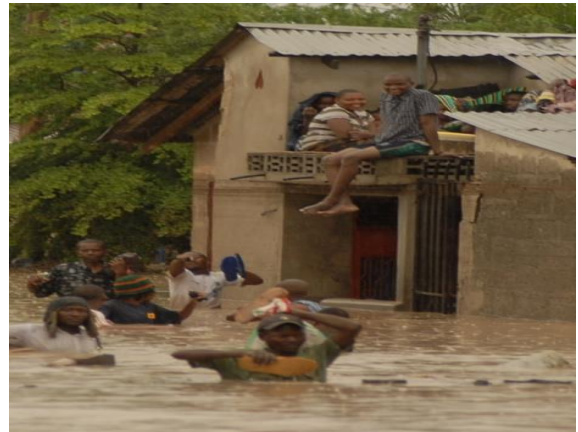
**Image 6.18.** Shows the flood proof roof structure. Source: Field survey, (2025)

**Roof and Building Elements:** Roofs can serve as **flood-safe zones**, while windows, doors, gutters, and basements require waterproofing to prevent interior flooding. Suspended buildings allow coexistence of hydrological and other land-use functions, especially where drainage paths conflict with development.

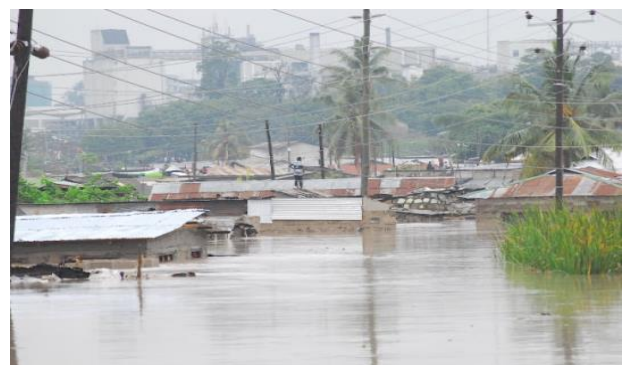
**Image 6.19.** Shows the areas prone to earth quakes at Luhanga river bay. Source: Field survey, (2025)

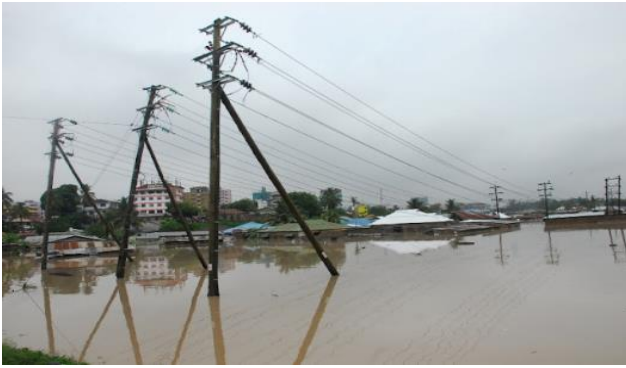
**Image 6.20.** Shows the areas prone to flood at Jangwani wetland. Source: Field survey, (2025)
