An Exploratory Study on Fire Safety in High-Rise Buildings with Mixed Occupancy in Urban Areas: Case of Sylhet City, Bangladesh

Abstract This research was conducted to assess fire hazard's vulnerability in the up-growing high-rise buildings with mixed-use occupancy types in Sylhet city, Bangladesh. The architectural properties of a built form can cause enormous casualties during fire incidents. Architectural properties such as building position, setbacks from its surroundings, floor height, egress and size, shape and orientation of atrium, any addition or alteration of the occupancy type, etc., had been taken into consideration for developing the research. The research was carried out based on a series of physical surveys. Later a comparative analysis had been designed concerning the standards mentioned in the existing building codes and regulations. This research also suggested the possible scope for further improvements in the building codes and future directions and standard guidelines for the mixed-use building design in this city.

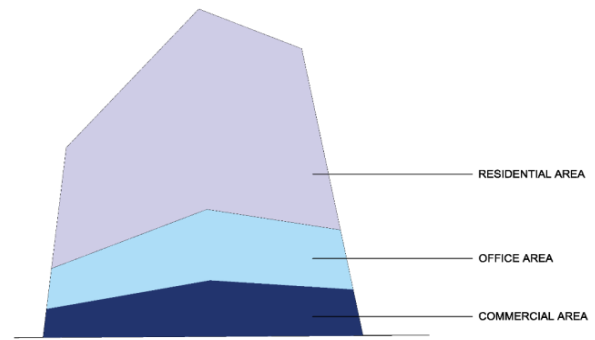
Figure 4. Mixed Occupancy of Sunrise Tower, Pathantula

Figure 4 and 5 shows that the commercial facilities were located at the bottom level and residential functions at the top level of the Sunrise Tower, Pathantula. Similar situations were found at the Arcadia and the Blue-water tower, Zindabazar (Figure 7, 8). Therefore, it would be fairly difficult to escape only through stairs from the residential levels during the fire hazards, due to higher number of occupants living there. On the other hand, Al-Hamra Tower, Chowhatta only had the office floors above the commercial facilities (Figure 6), but the average density of the occupants in each floor was still higher in proportion to the floor area.

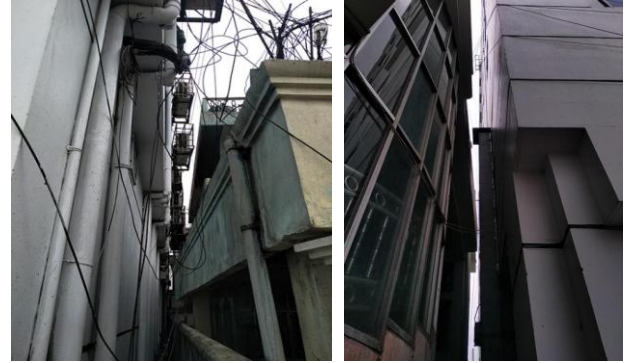
The study is illustrated by Table 3, the average setback of those four buildings from their surrounding plots. The Arcadia, Darshan Deuri, had an accepted setback of 5'-0" from both sides with open space and roads covering these sides and a front road of 50'-0" width, making it comparatively less vulnerable than the other three buildings. However, the other three buildings had minor setbacks in the right, left, and rear side, which could cause a significant and devastating hazard if any fire incident occurs (Figure 9, 10). Fewer setbacks can lead to the risk of spreading fire hazards even if the ignition source is outside the surrounding plots due to the debris's aerial movements and other combustible particles. Besides, a wider front road is also essential to allow

Figure 9. Narrow setback spaces at the back & east side of Sunrise Tower

- Corner plots are highly recommended for mixed-use buildings. The access road in the front should be at least 30 feet wide. Setback space from other sides should be preserved and regularly monitored.

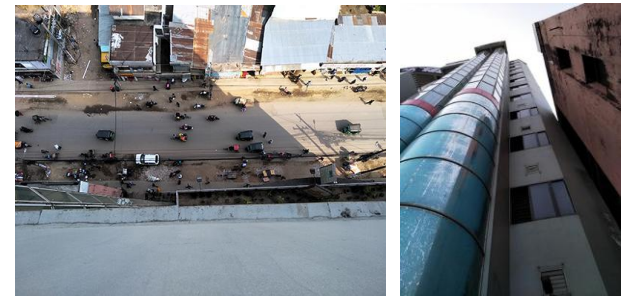
Figure 10. Marginal setback spaces at the front and north side of Al-Hamra Tower, Chowhatta

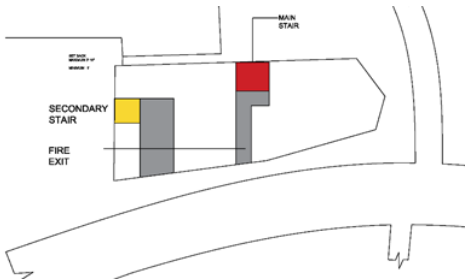
Sunrise Tower and Blue Water Tower had open-well stairs, which were not recommended as a fire escape. Open-well stairs can result in centrifugal motion. As a result, people can get severely injured due to head spinning.

Name of the selected building	Nos of fire exits	Width of the fire exit	Type of fire stair	Fire stair position on the floor Plan	Remarks
Sunrise Tower, Pathantula	2 (1 open)	5'-4"	Open-well

- Atrium is not recommended. If provided, it should not be covered on top and unprotected from sides.
- At least two staircases should be made compulsory for mixed-use high-rise buildings. Automatic sprinkler systems must be installed for basement level and exit routes.

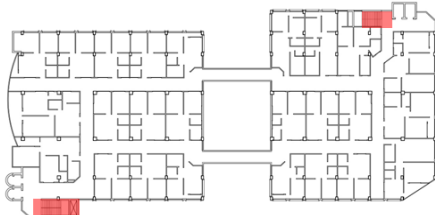
On the contrary, the Al-Hamra Tower and the Arcadia's fire stairs were dog-legged stairs, which is relatively better than open-well stair for the emergency escape. remained always closed in the exit floor level, adding more vulnerability to fire incidents. The minimum width of the fire exit routes was ensured in all four buildings. Handrail materials were not fire-resistant.

Not sufficient
Al-Hamra Tower, Chowhatta	2 (1 open)	4'-6"	Dog-legged

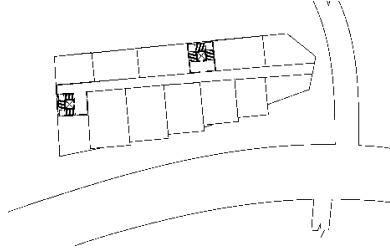
Al-Hamra Tower has an open-to-sky atrium, it lacked protection by fire-resistant materials from the sides.

no atrium	-
Al-Hamra Tower, Chowhatta	1	38'-4" × 41'-6" × 42'-4"

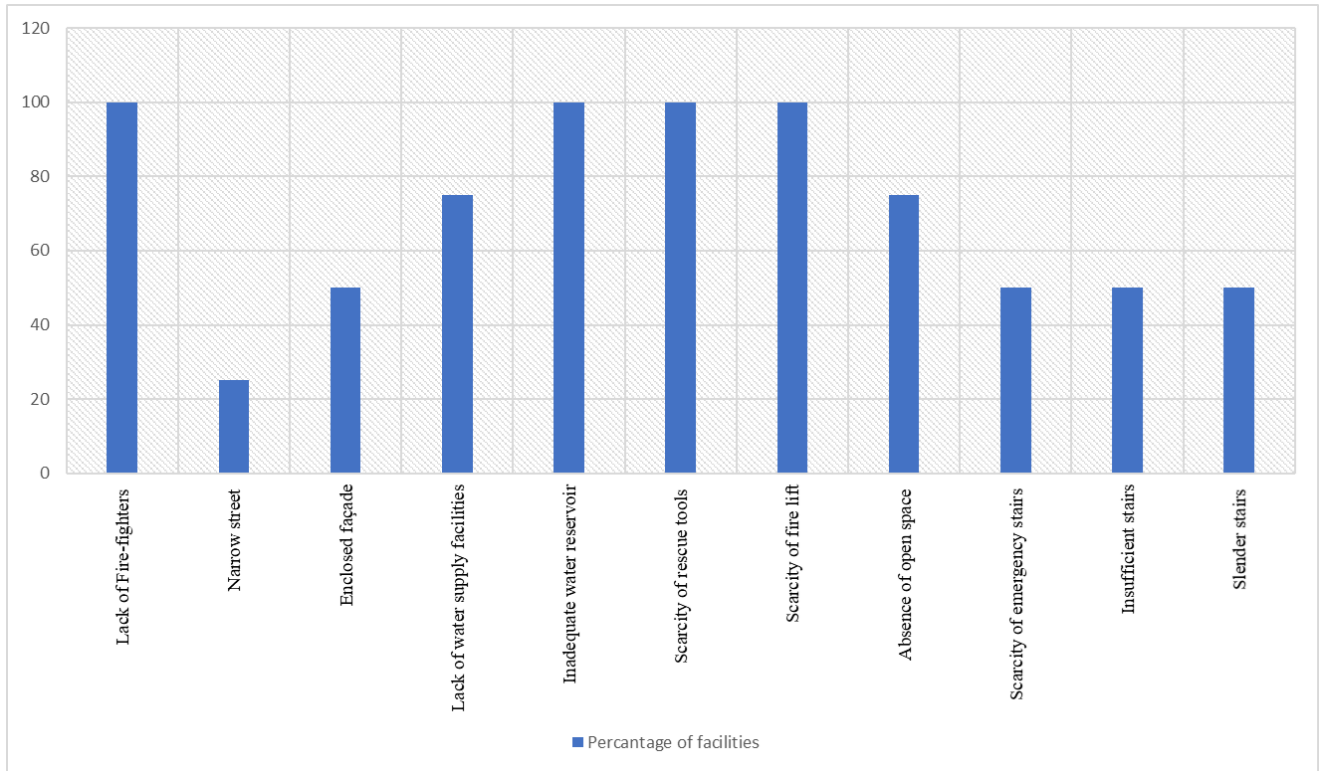
Figure 11. Anticipated hurdles for fire management during fire accidents in vulnerable high-rise buildings. (Source: Data collected from field survey, 2020 and variables adopted from [8])

The study identified and ranked several obstacles affecting fire management in the high-rise buildings (Figure 11). These constraints include lack of fire-fighters, narrow streets, enclosed façade, lack of water supply facilities, inadequate water reservoir, scarcity of rescue tools, fire lifts and emergency stairs, slender and insufficient stairs and absence of open space to be used as the assembly ground [8].
